Harding Lawson Associates

BUILDING 123 INVESTIGATION NAVAL STATION, TREASURE ISLAND HUNTERS POINT ANNEX SAN FRANCISCO, CALIFORNIA

HLA Job No. 02176,159.02

November 2, 1988

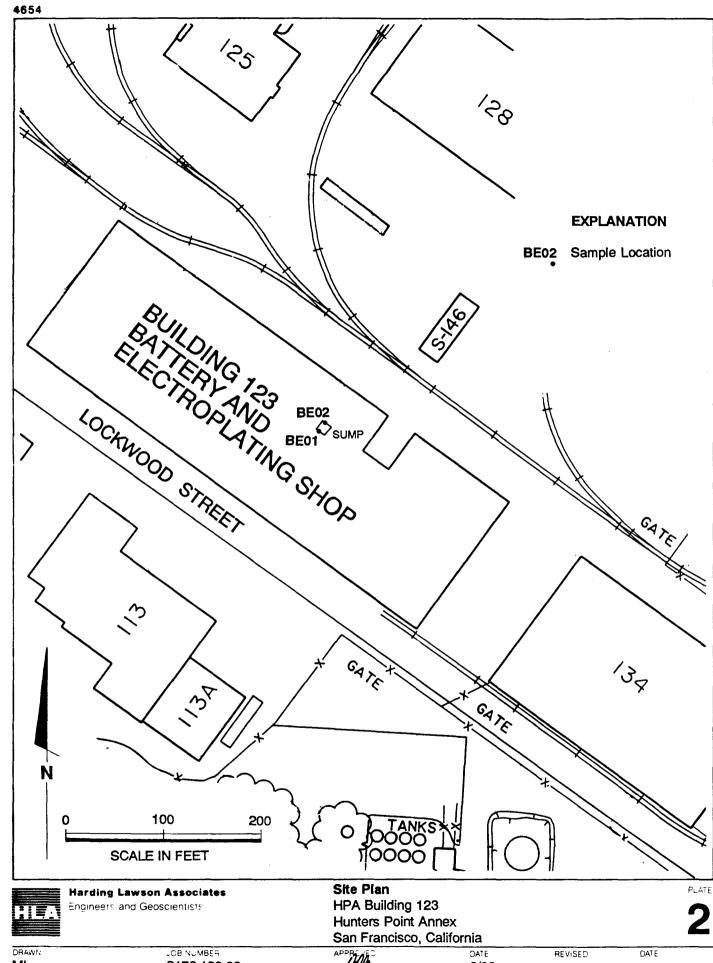
Plate 2 Site Map

Two sludge samples were collected on May 17, 1988 from a sump in the north central portion of Building 123 (Plate 2). The sump is approximately 3 feet wide, 5 feet long and 2 feet deep. Approximately 1.5 feet of fluid was found in the sump.

Sludge samples were collected from two locations inside the sump (Plate 2) using a dedicated clean, glass jar secured with dedicated nylon cord. The jar was lowered to the sump bottom at each sampling location. The jars were then retrieved and the recovered sludge was poured directly from the glass jar to the appropriate laboratory-supplied sample container for the specified analyses. The sample containers were labeled and stored in an ice chest containing blue ice (cooled to approximately 4°C) until they were delivered to the laboratory at the end of the day.

During the site investigation, a second sump was observed inside Building 123 approximately 20 feet north of the sampled sump. This second sump was also filled with liquid; however, machinery obstructed access to the second sump.

We recommend that the sludge/fluid material in the sump at Building 123 be further characterized for TPH and oil and grease, removed, and properly disposed by a licensed waste disposal contractor in a timely manner. Once the sump is empty, the sump walls should be cleaned and inspected for leaks/cracks that may provide pathways for the sump liquid to enter the surrounding soils or ground water. The second sump inside Building 123 should also be characterized so that the liquid inside it can be removed and the sump can be inspected. Personnel working within the building (employees of All Make Auto, First Metal and Chemical, and Sunray Trucking) may have the potential for dermal exposure to the material in these sumps.

Activities such as engine block cleaning in the vicinity of the sump or oil disposal into the sump should cease as soon as possible. Because this site is part of the ongoing Remedial Investigation (RI) at HPA, (IR-10, the Battery and Electroplating Shop), a full characterization of soils, floor drains, and ground water at the site is not necessary at this time but is included in the RI. The data collected during this investigation should be reviewed and considered during the RI.
